Appendix A

Actions on Previous MDPH Recommendations

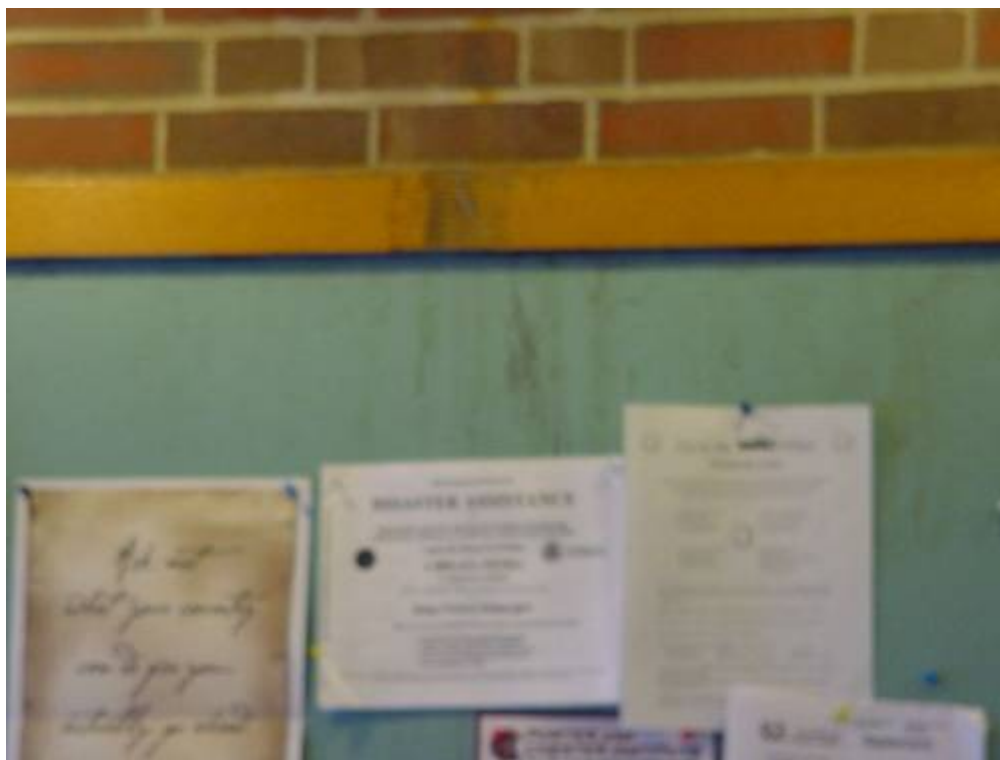
Picture A-1

Action Taken: The cork board in the main lobby was still in place and may be providing a continued source of musty odors (Picture A-1). In addition, visible mold and water damaged materials were observed in the Coast Guard room, however the room was unoccupied and a sign was posted restricting access (Pictures A-2 and A-3).

Water Damaged Cork Board in Main Hallway

- **Remove and replace any mold contaminated/water damaged materials (e.g. carpeting/padding, cork board, gypsum wallboard). This measure will remove actively growing mold colonies that may be present.**

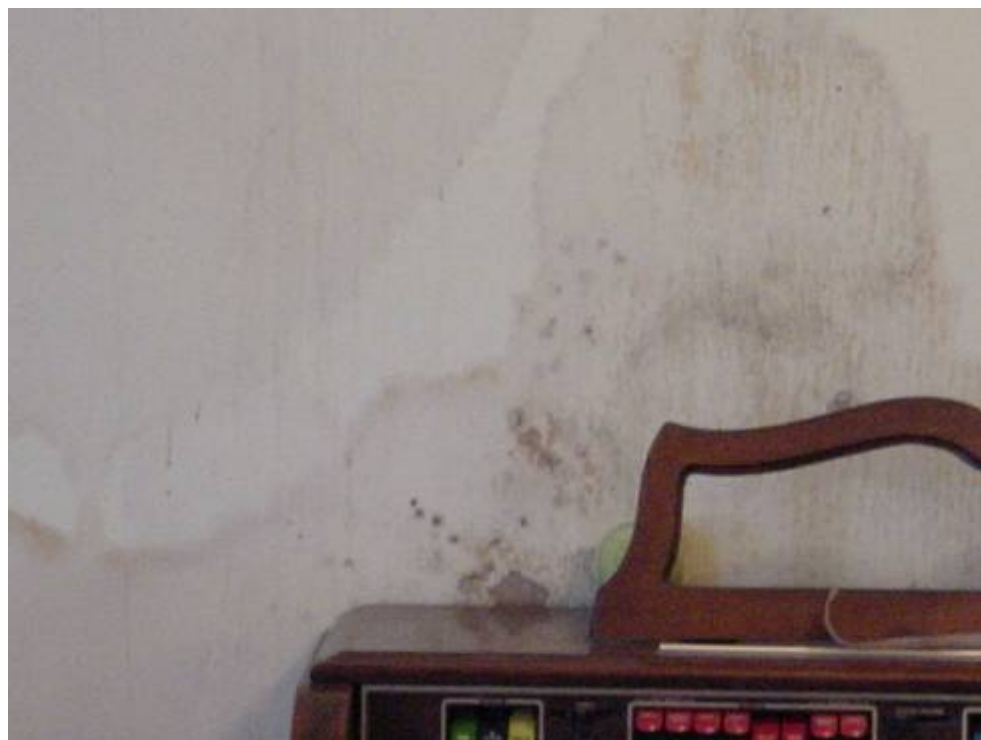
Picture A-2

Mold-Colonized Cork Board in Coast Guard Room

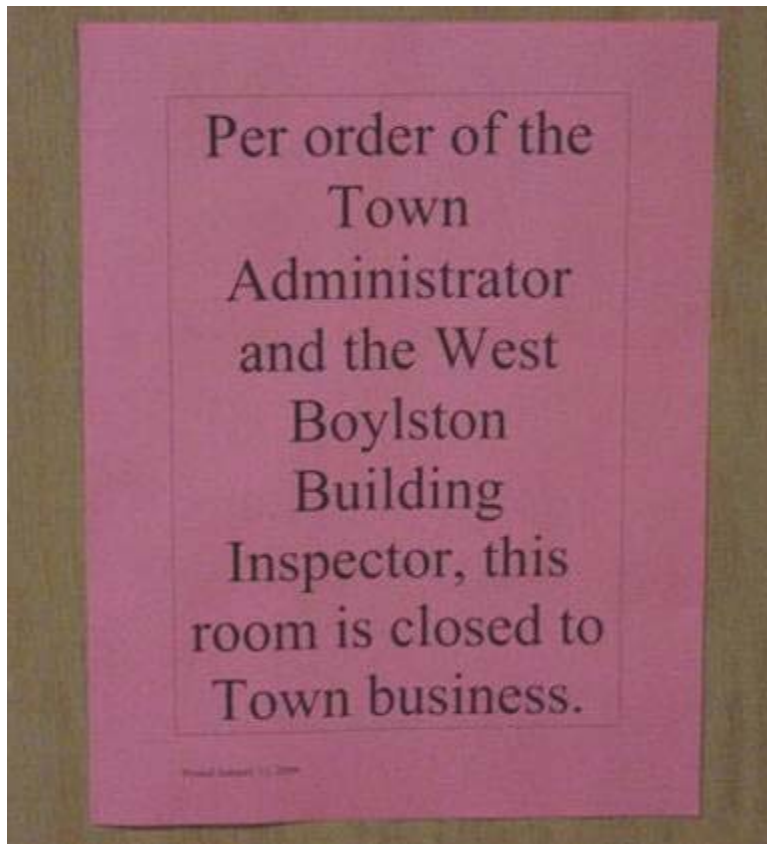
Picture A-3

Sign Posted Restricting Access to Coast Guard Room

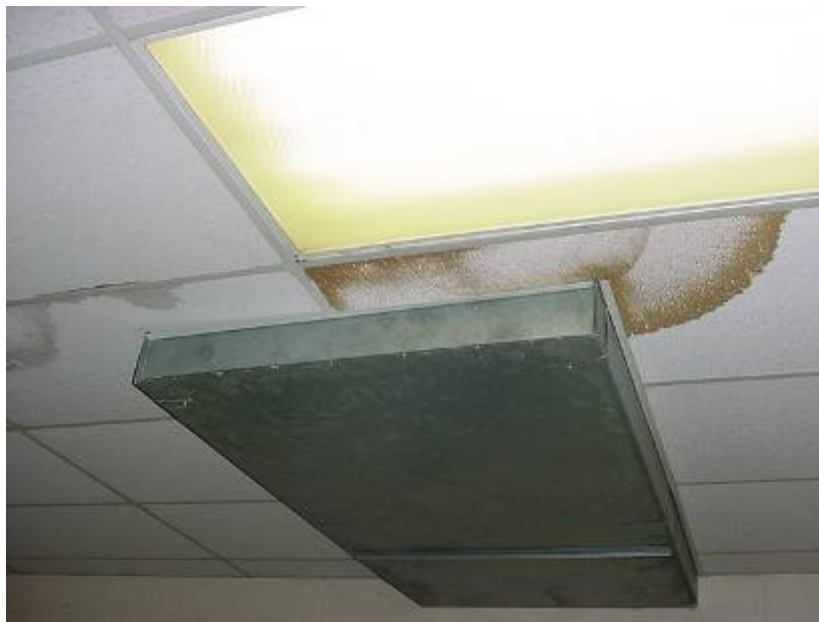
Picture A-4

Action Taken: The roof is reportedly patched as needed by the West Boylston Streets and Parks Department, however, water damaged building materials (e.g., carpeting, walls, ceilings) and active leaks were observed and/or reported by building occupants in a number of areas, most notably in the Town Administrator's office (Pictures A-4 through A-11).

Water Damaged Ceiling Tiles

- **Ensure roof leaks are repaired. Once repaired replace any water-stained ceiling tiles. Disinfect areas of water leaks with an appropriate antimicrobial.**

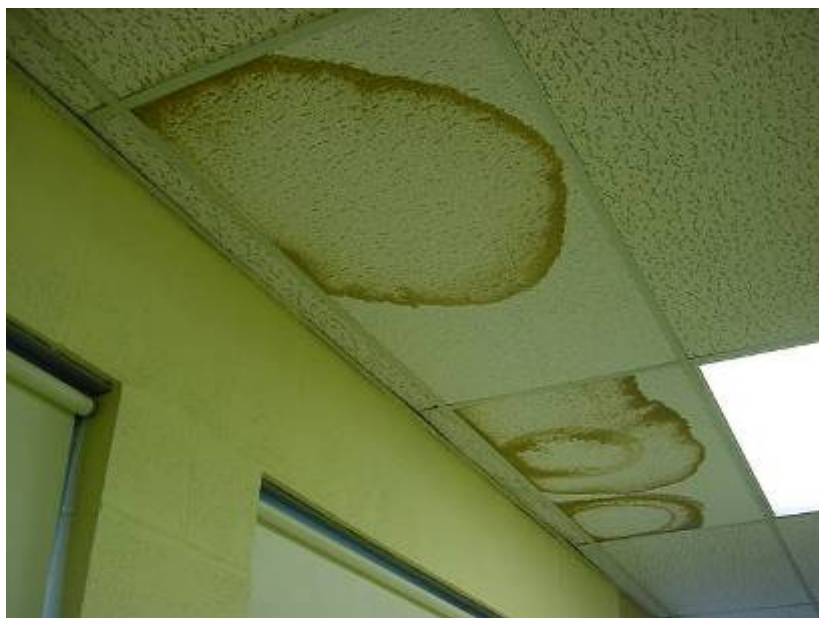
Picture A-5

Water Damaged Ceiling Tiles

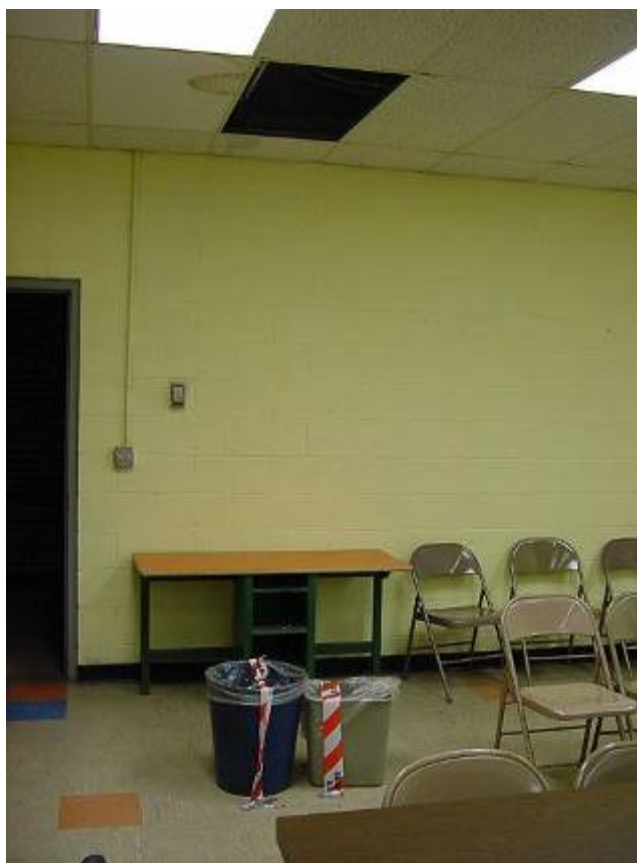
Picture A-6

Action Taken: In a number of areas tiles have been permanently removed due to chronic roof leaks; open utility holes were observed in a few areas (Pictures A-6 and A-14).

Buckets Catching Rain Water in South Meeting Room

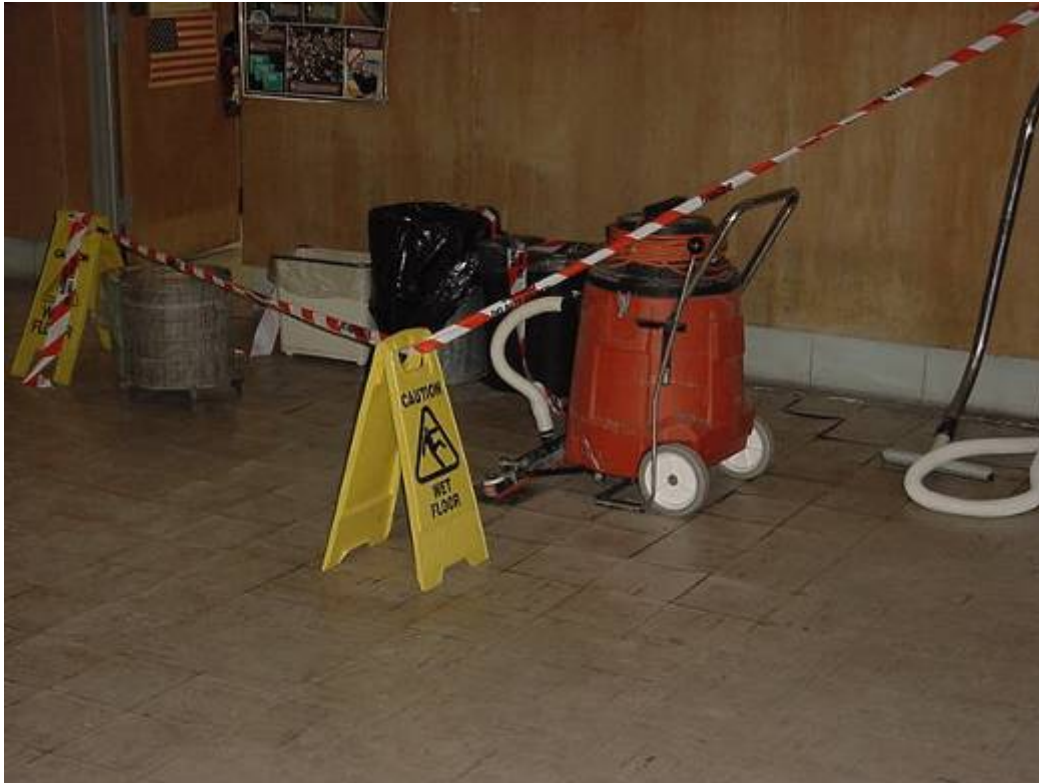
Picture A-7

Buckets Catching Rain Water in Main Hallway

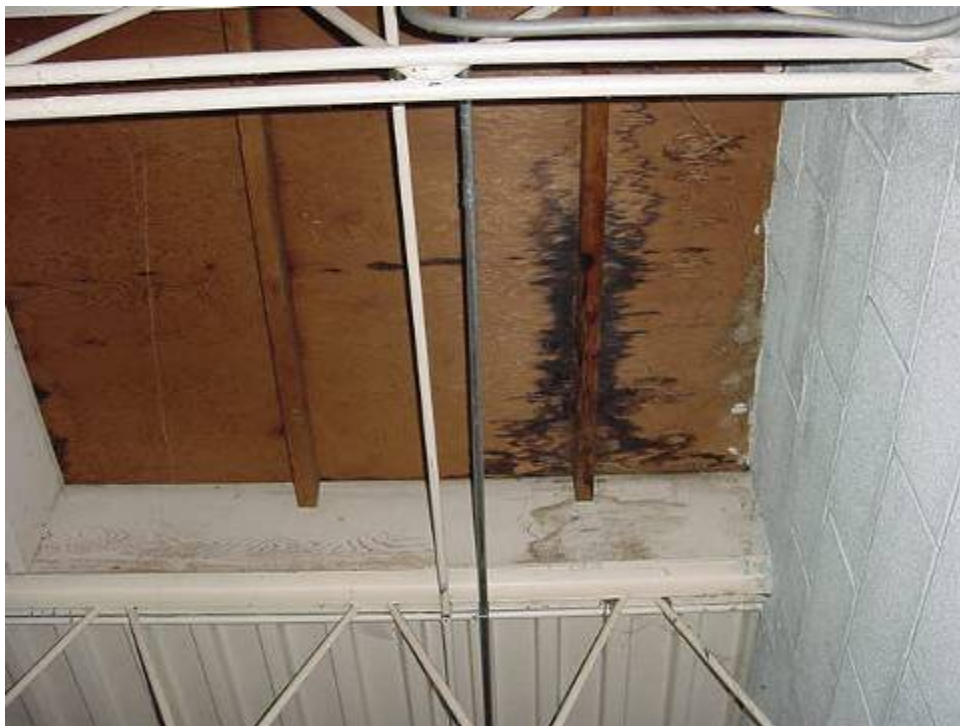
Picture A-8

Water Damaged Wood Plug in Former Skylight Main Hallway, Dark Stain Indicates Water Penetration

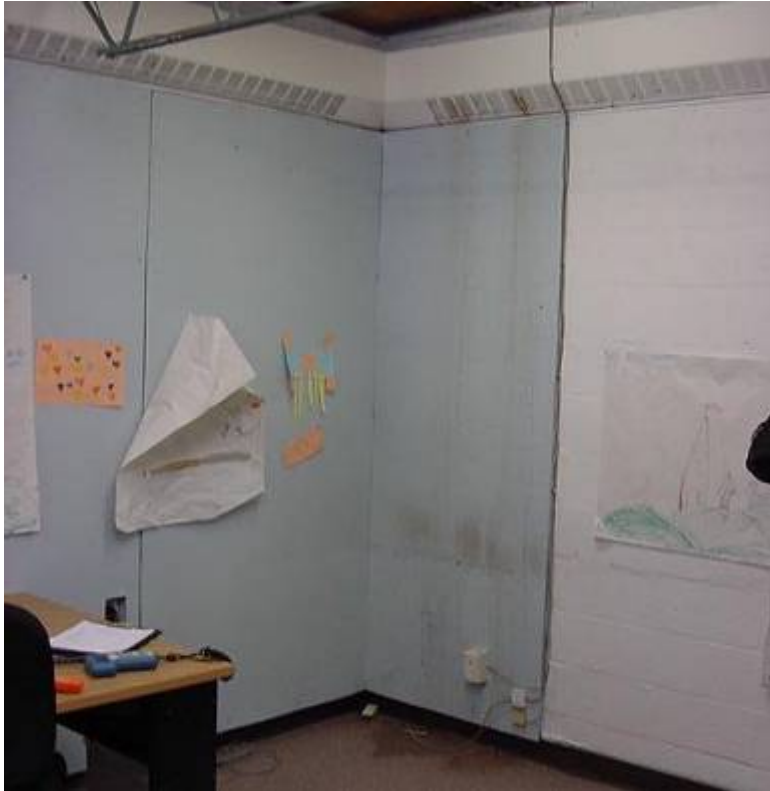
Picture A-9

Active Roof Leak, Water Damaged Gypsum Wallboard and Carpeting in Town Manager's Office, Note Carpet and Wall were Moistened at the Time of the Assessment

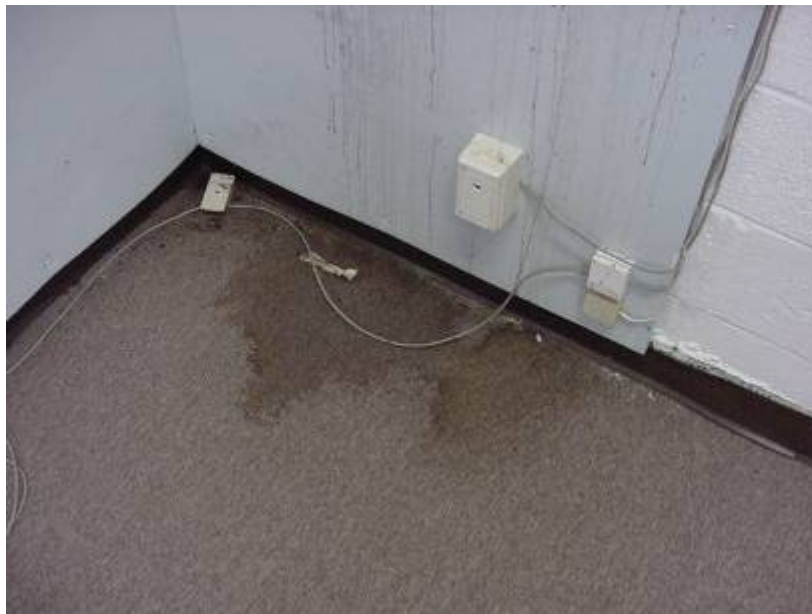
Picture A-10

Close-Up of Water Damaged Carpet in Town Manager's Office, Note Carpet and Wall were Moistened at the Time of the Assessment

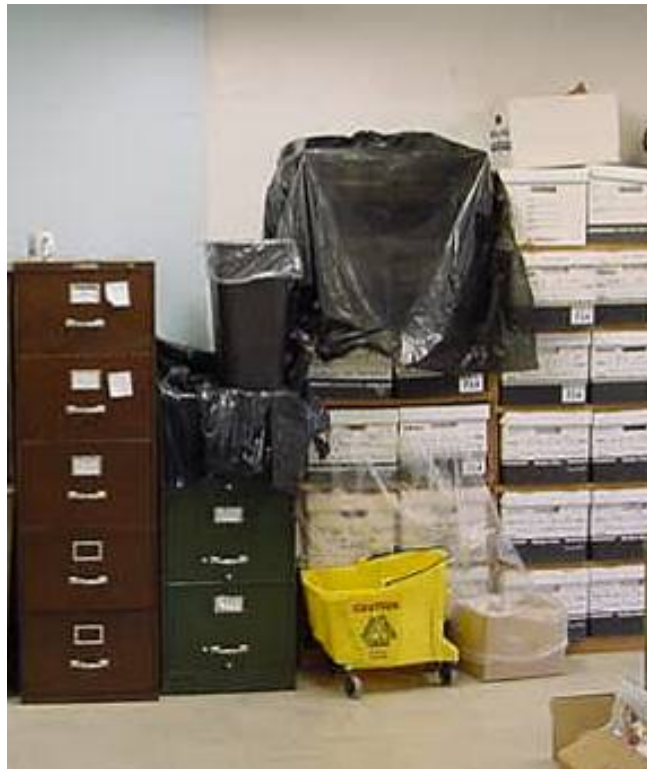
Picture A-11

Buckets and Trash Bags Covering/Protecting Stored Porous Items in Office from Leaks

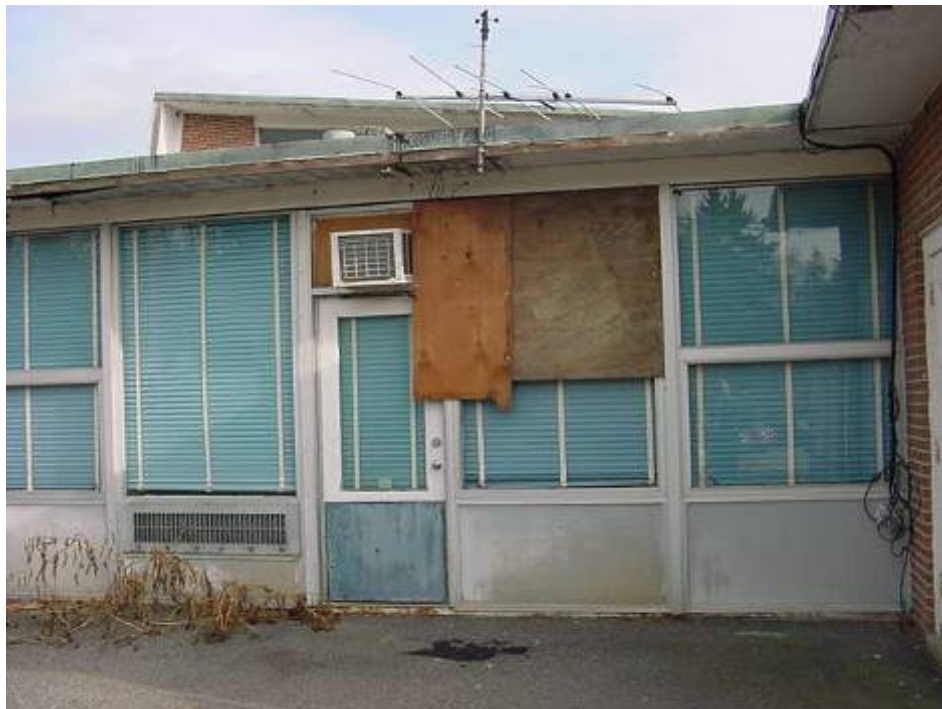
Picture A-12

Action Taken: In some cases broken windows were not replaced but boarded-up with plywood (Picture 12). In addition, condensation was observed on several windows which can provide another source of moisture within the building (Picture 13).

Windows Boarded-Up with Plywood

- **Replace/repair broken windows to prevent water leaks and subsequent microbial growth.**

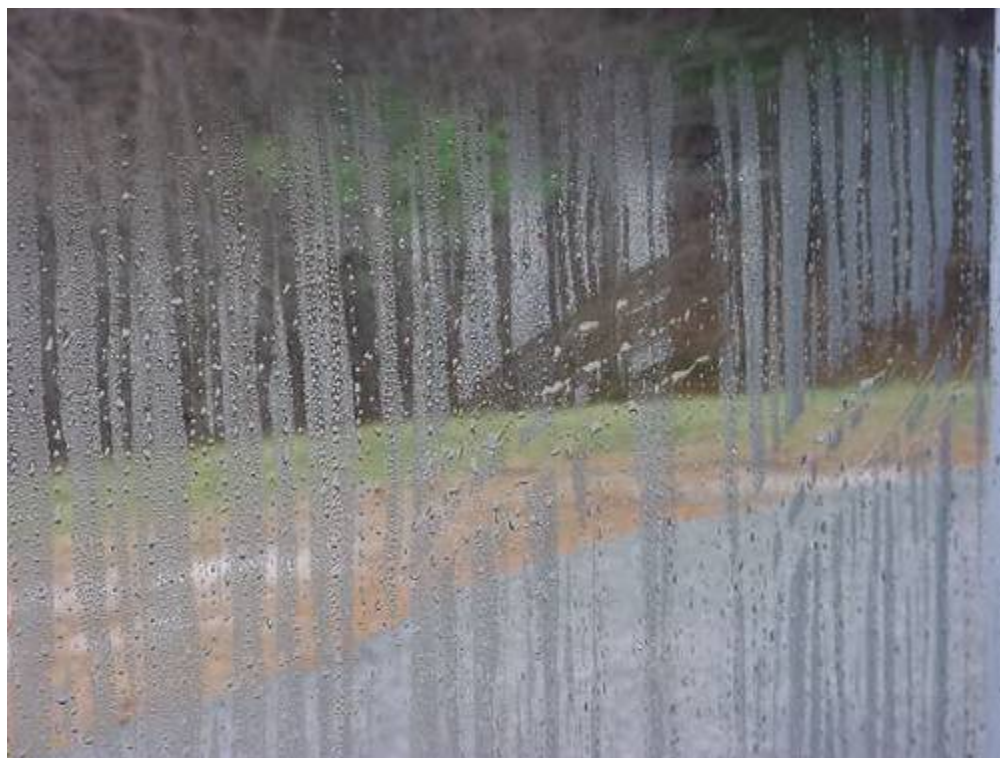
Picture A-13

Condensation on Interior of Window

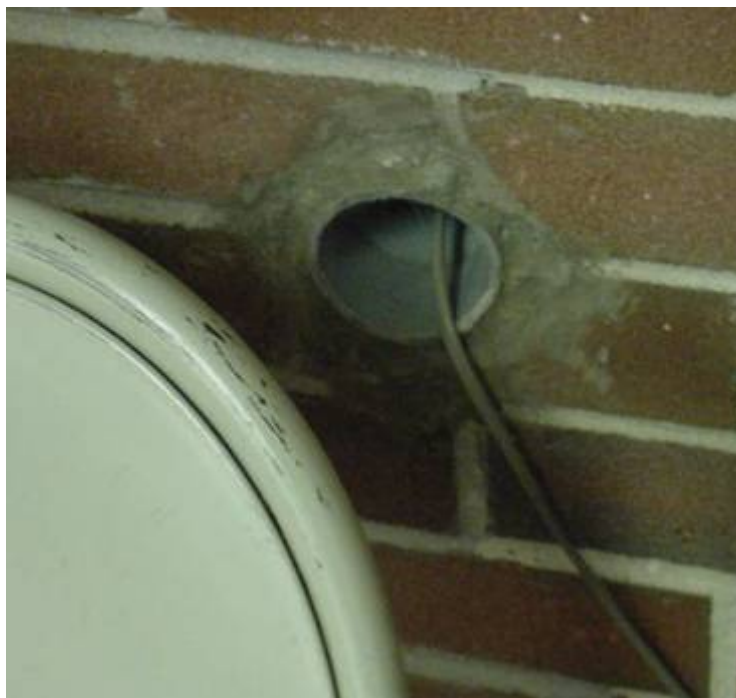
Picture A-14

Open Utility Hole in Main Hallway

- **Replace any missing ceiling tiles and fill utility holes, to prevent the migration of odors, dust and particulate matter between rooms.**

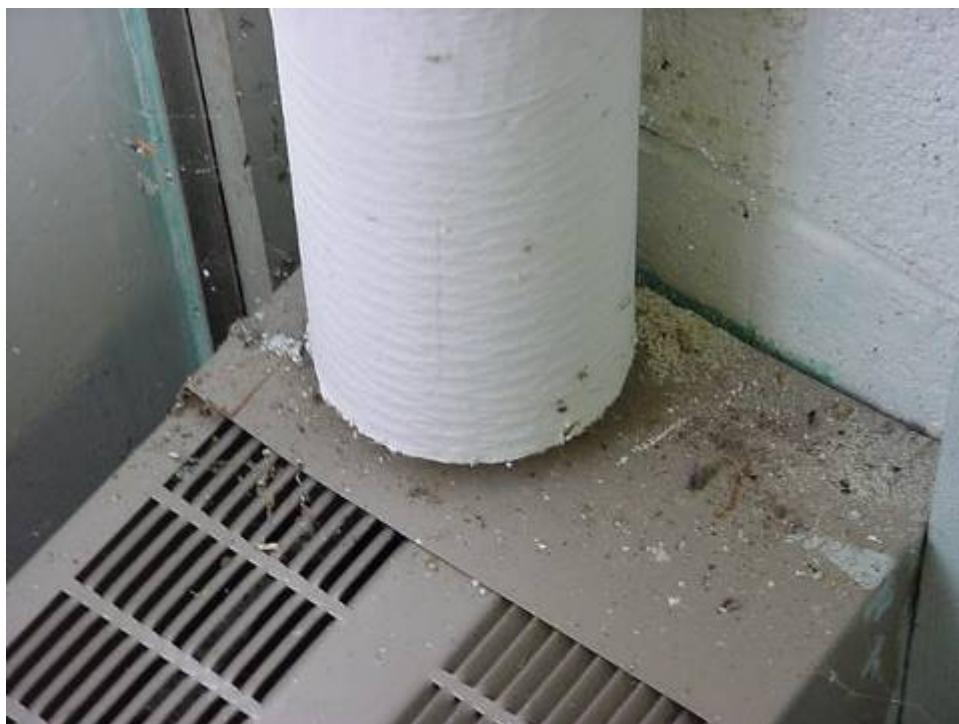
Picture A-15

Action Taken: More work is needed in several areas to reduce clutter and improve dust control/cleaning (Picture A-15).

Dust/Debris on Flat Surfaces in Office

- **Relocate or consider reducing the amount of materials stored in office space to allow for more thorough cleaning. Clean items regularly with a wet cloth or sponge to prevent excessive dust build-up.**

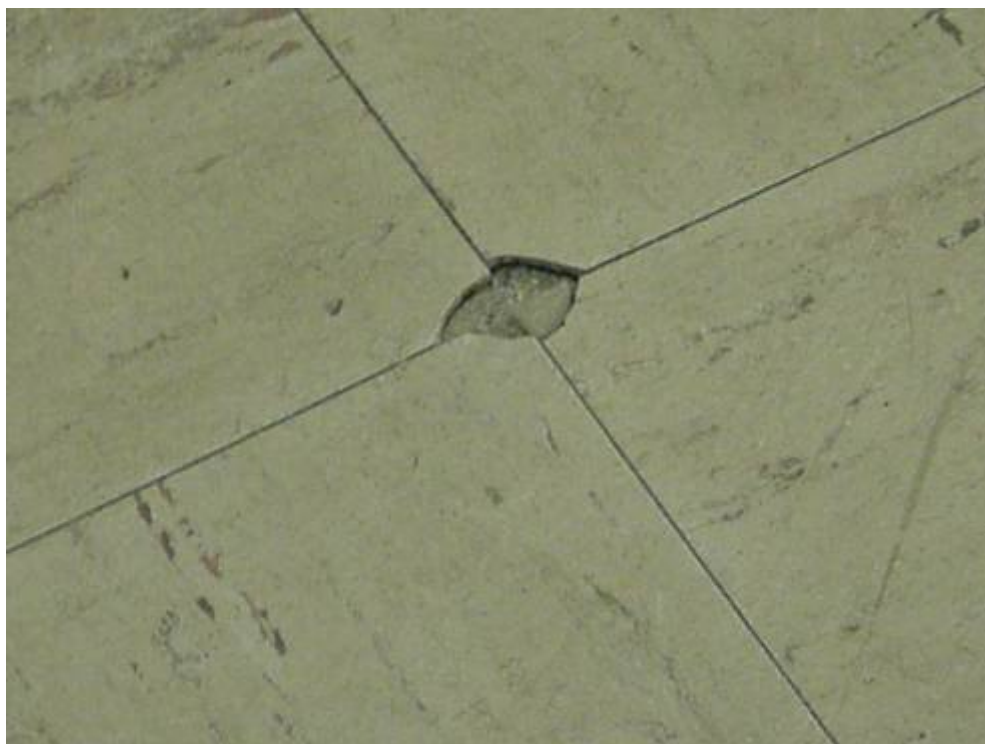
Picture A-16

Action Taken: Damaged/loose floor tiles were observed in several areas due to current roof leaks (Pictures A-16 and A-17).

Damaged Floor Tile

- **Remediate any damaged/friable asbestos containing materials in conformance with all applicable Massachusetts' asbestos abatement and hazardous materials disposal laws.**

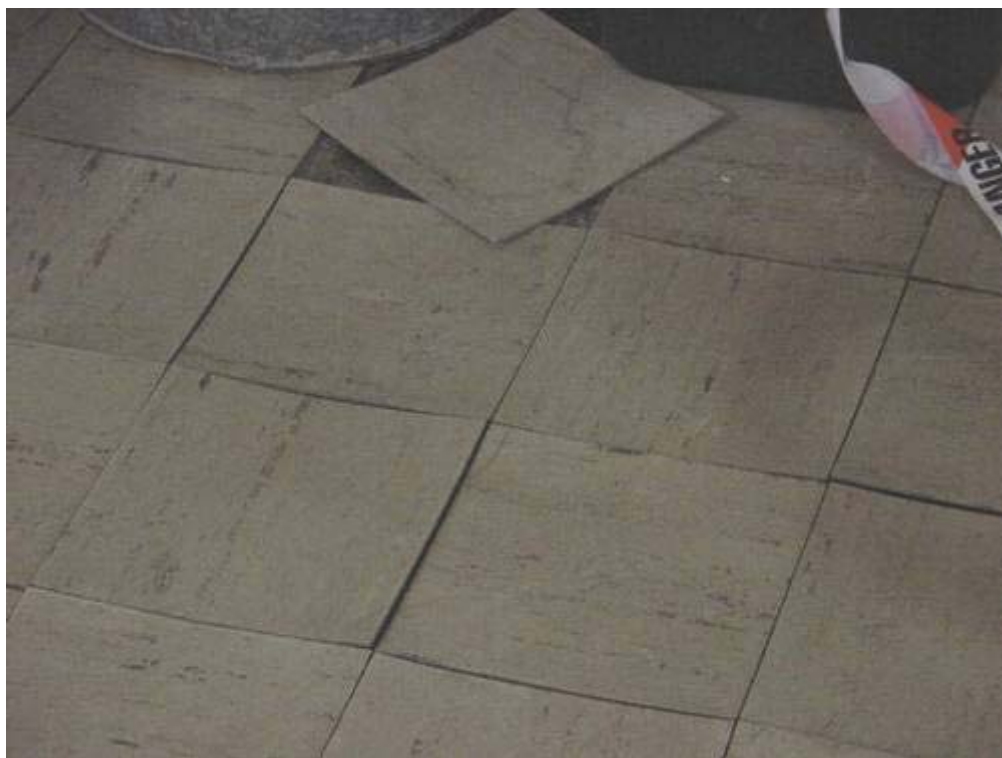
Picture A-17

Loose/Lifting Floor Tiles

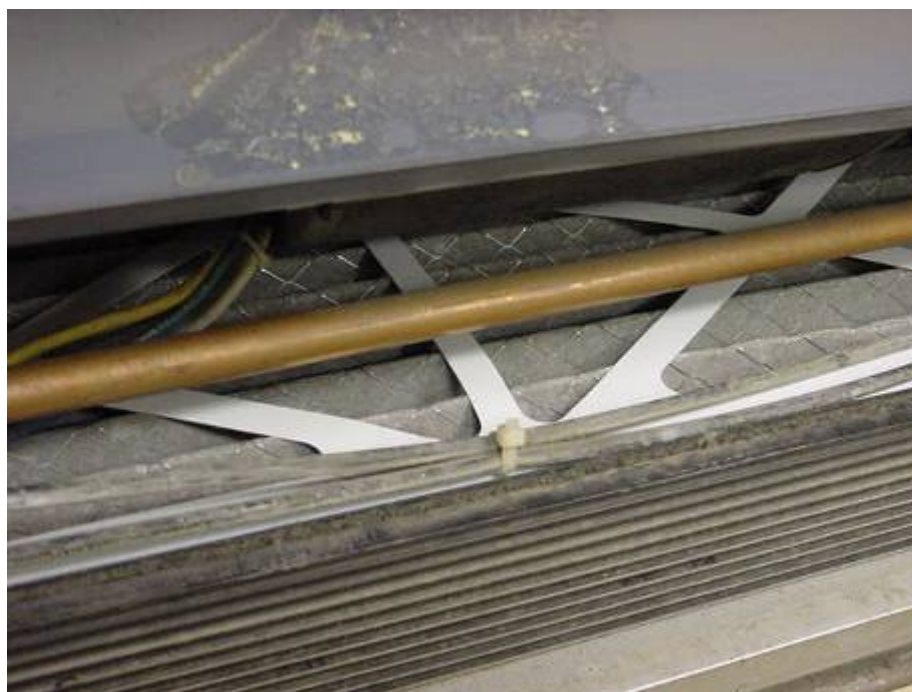
Picture A-18

Action Taken: Filters appeared clean with the exception of the filter in the south meeting room, which was difficult to access (Picture A-18). However the interiors of several univents had cobwebs or accumulated dust build-up (Picture A-19).

Dirty Filter Inside Univent-South Meeting Room

- **Change filters for window-mounted air conditioners and air-handling equipment as per the manufacturer's instructions or more frequently if needed. Vacuum interior of units prior to activation to prevent the aerosolization of dirt, dust and particulates.**

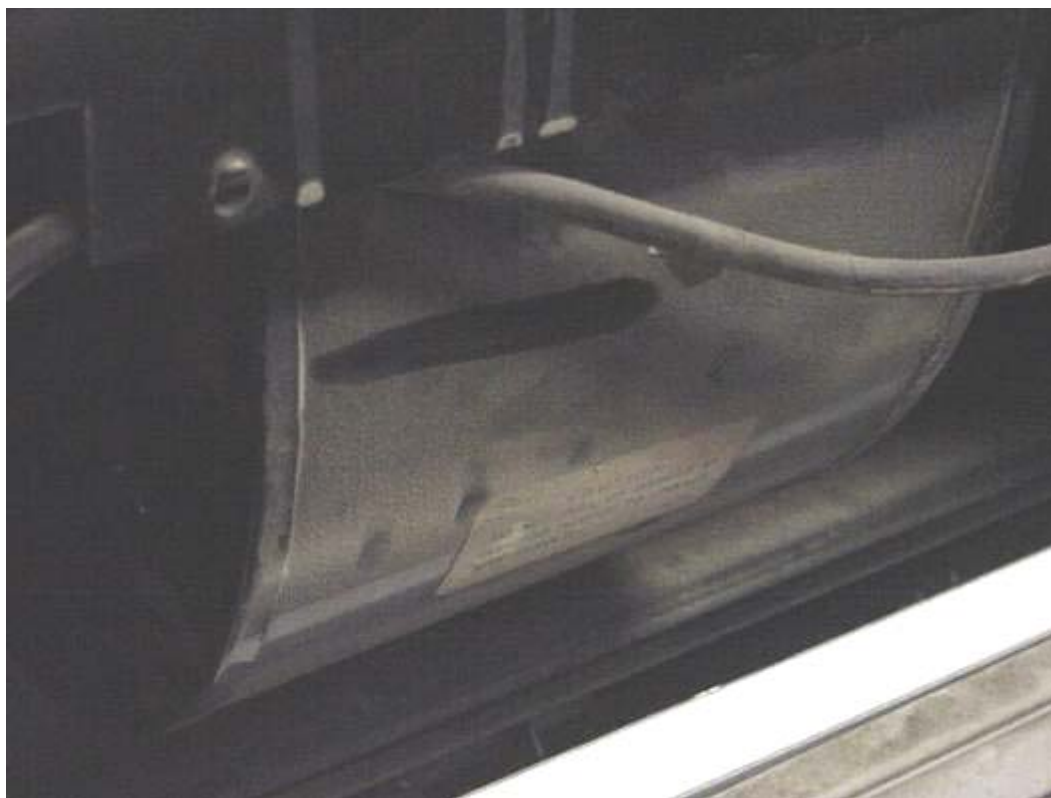
Picture A-19

Dust Build-Up on the Interior of Univent
